**Flood Control Project Maintenance  
Levee Inspections**

**Fall 2018 Levee Maintenance Deficiency Summary Report**

**Reclamation District No. 1660 Tisdale**

**Levee Inspection Report By Mile - Fall 2018**

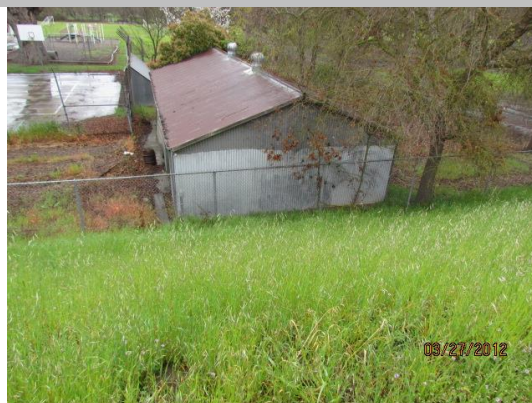
Photo 1 of 1 : FA\_2018\_RD1660\_8\_12\_20180905\_00006.jpg

LM Start	0.05	Rating **	M	Issue No.	12
LM End	0.05	Issue Type +	En	Location *	LS
Category	Earthen Levee			GPS Latitude/Longitude	
				Start	End
Item	Encroachments			39.062643 °	39.062643 °
				-121.837857 °	-121.837857 °
DWR ID	DWR_RD1660_01_s_2012_12				
Comment Code					
BU : Building					
Inspector Comment

View of the building and fence at the landside toe.

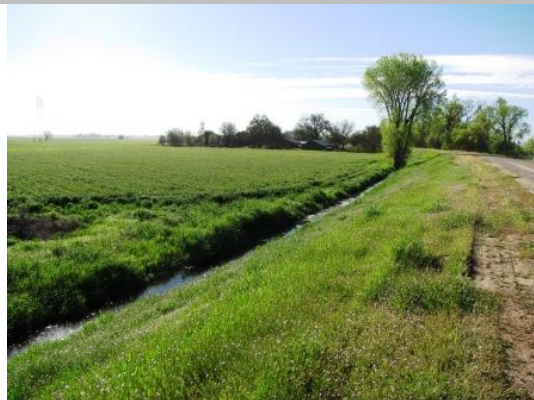
Photo 1 of 1 : FA\_2018\_RD1660\_8\_9\_20180905\_00005.jpg

LM Start	1.10	Rating **	M	Issue No.	9
LM End	1.45	Issue Type +	En	Location *	LS
Category	Earthen Levee			GPS Latitude/Longitude	
				Start	End
Item	Encroachments			39.047610 °	39.043221 °
				-121.838802 °	-121.835815 °
DWR ID	DWR_RD1660_01_s_2012_9				
Comment Code					
DT : Ditch					
Inspector Comment

View of a ditch along the landside toe.

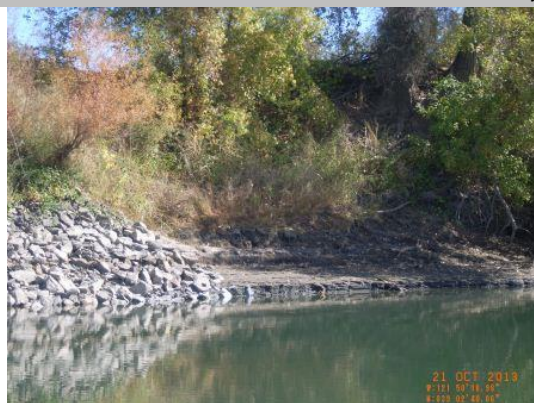
Photo 1 of 1 : FA\_2018\_RD1660\_8\_8\_20180905\_00004.jpg

LM Start	1.33	Rating **	M	Issue No.	8
LM End	1.36	Issue Type +	Ma	Location *	WS
Category	Supplemental			GPS Latitude/Longitude	
				Start	End
Item	2017 USACE Erosion Survey, DRAFT			39.044361 °	39.043916 °
				-121.837654 °	-121.837305 °
DWR ID	DWR_RD1660_01_f_2018_8				
Comment Code					
Inspector Comment					
2017 Site ID: SAC 120.6 L					
Status: Eroding					
2017 Field Notes: No observed change.					
Site History: 2009 - Erosion on levee toe where an old cobble site is failing. 2011 - Some new minor erosion. 2012 - Site extended downstream, bank is being impacted from the weight of the trees.					
2013 - Minor new erosion at the toe. 2015 - Minor new erosion at toe.

USACE 2013 Photo #1

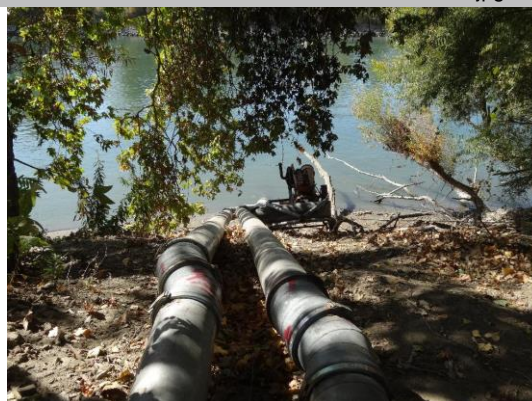
Photo 1 of 3 : UCIP\_FA\_2018\_22543\_38142.jpg

Comment Code						
Inspector Comment						
FS_ID:22543 DS_ID:22484 EP_NO: 16476 Repair Type: Non-Urgent Crossing Status: Found UCIP Comments: - 16-inch old steel pipe abandoned. Abandoned pipe found on landside levee toe.- abandoned power pole on waterside.- mobile diesel pump on channel bank.- attached tin pipes exposed on levee surface. FIELD_STRUCT_DESC: 14-inch steel irrigation discharge pipe through the levee crown, at an unknown depth. Two 12-inch tin pipes on the surface of the levee slopes, attached to the existing 14-inch steel pipe. Pipe discharges into an irrigation ditch on the landside (LS). Air vent on the LS shoulder. (Plans to grout a 25-foot section of pipeline through the levee authorized under Permit No. 16476, 1995 - Reclamation District No. 1660 [RD1660]). FS Date: 10/10/2013

WS view: two exposed 12" tin pipes on levee slope. These pipes connected to the pump on river bank.

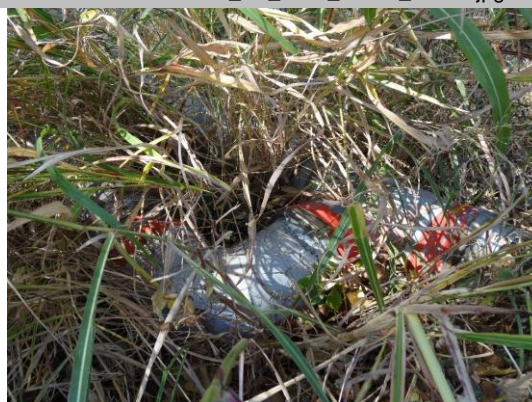
Photo 2 of 3 : UCIP\_FA\_2018\_22543\_38141.jpg

WS view: two exposed 12" tin pipes on levee slope.

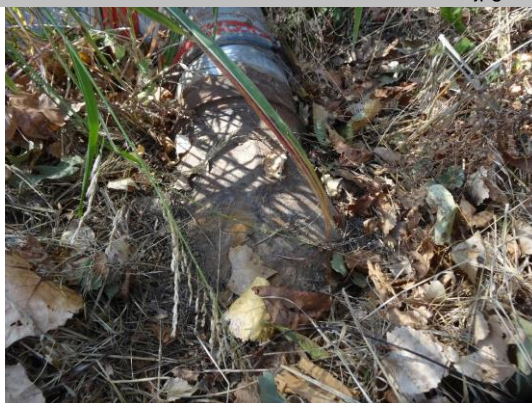
Photo 3 of 3 : UCIP\_FA\_2018\_22543\_38140.jpg

Comment Code						
Inspector Comment						
FS_ID:22543 DS_ID:22484 EP_NO: 16476 Repair Type: Non-Urgent Crossing Status: Found UCIP Comments: - 16-inch old steel pipe abandoned. Abandoned pipe found on landside levee toe.- abandoned power pole on waterside.- mobile diesel pump on channel bank.- attached tin pipes exposed on levee surface. FIELD_STRUCT_DESC: 14-inch steel irrigation discharge pipe through the levee crown, at an unknown depth. Two 12-inch tin pipes on the surface of the levee slopes, attached to the existing 14-inch steel pipe. Pipe discharges into an irrigation ditch on the landside (LS). Air vent on the LS shoulder. (Plans to grout a 25-foot section of pipeline through the levee authorized under Permit No. 16476, 1995 - Reclamation District No. 1660 [RD1660]). FS Date: 10/10/2013

WS view: two exposed tin pipes joined together and connected to 14-inch steel pipe on levee slope.

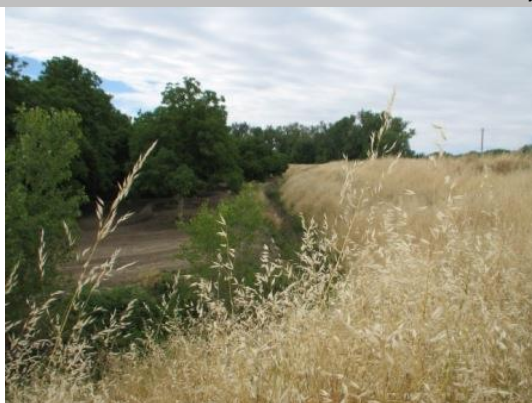
Photo 1 of 1 : FA\_2018\_RD1660\_8\_1\_20180905\_00001.jpg

LM Start	2.01	Rating **	U	Issue No.	1
LM End	2.34	Issue Type +	En	Location *	LS
Category	Earthen Levee			GPS Latitude/Longitude	
				Start	End
Item	Encroachments			39.037640 °	39.034416 °
				-121.828421 °	-121.825698 °
DWR ID	DWR_RD1660_01_s_2012_1				
Comment Code					
DT : Ditch					
Inspector Comment

View of a large ditch along the landside toe.

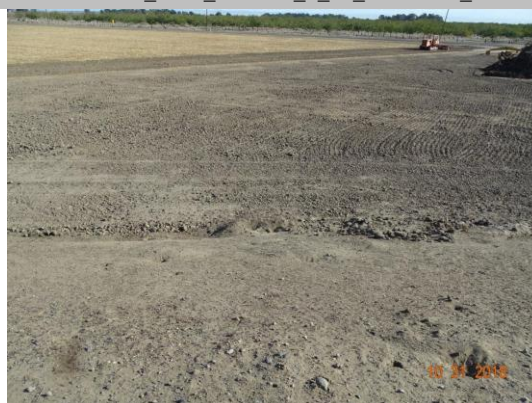
Photo 1 of 1 : FA\_2018\_RD1660\_8\_21\_20181102\_00019.jpg

LM Start	2.38	Rating **	U	Issue No.	21
LM End	2.38	Issue Type +	Ma	Location *	LS
Category	Earthen Levee			GPS Latitude/Longitude	
				Start	End
Item	Animal Control			39.034032 °	39.034032 °
				-121.825120 °	-121.825120 °
DWR ID	DWR_RD1660_01_f_2018_21				
Comment Code					
A3 : No rodents visible, but rodent burrows visible; need to backfill and compact or grout burrows.					
Inspector Comment					
Repair the rodent holes along the landside slope.

View of rodent holes along the landside slope.

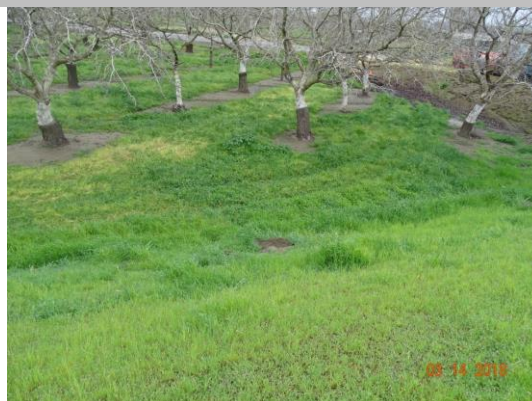
Photo 1 of 1 : FA\_2018\_RD1660\_8\_20\_20180905\_00008.jpg

LM Start	2.57	Rating **	M	Issue No.	20
LM End	2.57	Issue Type +	Ma	Location *	LS
Category	Earthen Levee			GPS Latitude/Longitude	
				Start	End
Item	Animal Control			39.031625 °	39.031625 °
				-121.823492 °	-121.823492 °
DWR ID	DWR_RD1660_01_s_2018_20				
Comment Code					
A3 : No rodents visible, but rodent burrows visible; need to backfill and compact or grout burrows.					
Inspector Comment					
Repair the rodent holes along the landside slope.

View of the rodent holes along the landside slope.

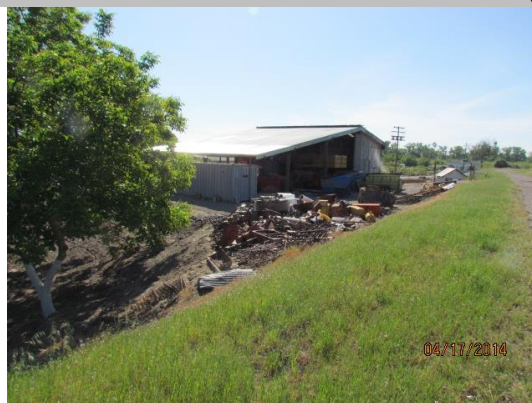
Photo 1 of 1 : FA\_2018\_RD1660\_8\_3\_20180905\_00003.jpg

LM Start	2.58	Rating **	M	Issue No.	3
LM End	2.58	Issue Type +	En	Location *	LS
Category	Earthen Levee			GPS Latitude/Longitude	
				Start	End
Item	Encroachments			39.031405 °	39.031405 °
				-121.823403 °	-121.823403 °
DWR ID	DWR_RD1660_01_s_2012_3				
Comment Code					
EQ : Equipment					
Inspector Comment

View of equipment along the landside slope.

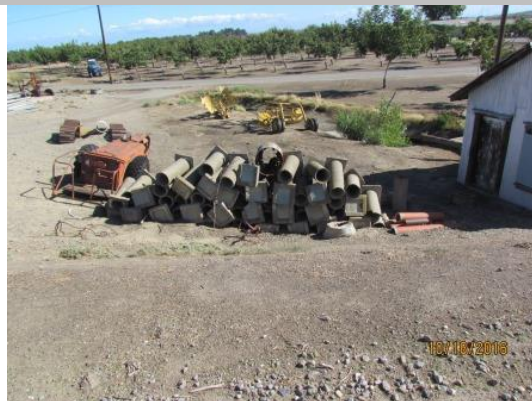
Photo 1 of 1 : FA\_2018\_RD1660\_8\_18\_20180905\_00007.jpg

LM Start	2.61	Rating **	M	Issue No.	18
LM End	2.61	Issue Type +	En	Location *	LS
Category	Earthen Levee			GPS Latitude/Longitude	
				Start	End
Item	Encroachments			39.031020 °	39.031020 °
				-121.823091 °	-121.823091 °
DWR ID	DWR_RD1660_01_f_2016_18				
Comment Code					
DE : Debris					
Inspector Comment					
Remove concrete pipes from the landside toe.

View of the concrete pipes within the levee easement.

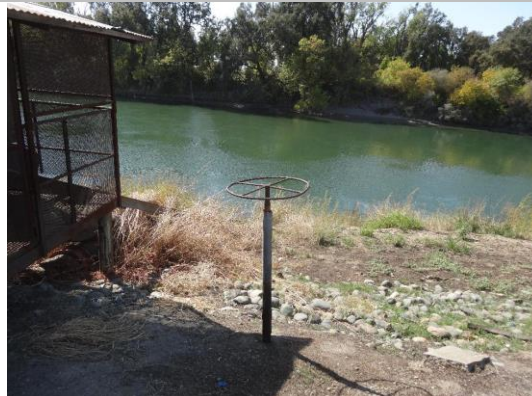
Photo 1 of 3 : UCIP\_FA\_2018\_22632\_38178.jpg

Comment Code						
Inspector Comment						
FS_ID:22632 DS_ID:22492 EP_NO: 10012 Repair Type: Non-Urgent Crossing Status: Found UCIP Comments: - abandoned pumphouse on landside toe. Needs confirmation from LMA or DWR Inspector about abandonment of pumphouse.- headwall on channel bank. FIELD_STRUCT_DESC: 24-inch steel irrigation discharge pipe through the levee, 24 feet below the crown. Slide gate on the waterside (WS) shoulder. Abandoned pump house on the landside (LS) slope. (Retention of a 24-inch steel pipe through the levee, 24 feet below the crown, slide gate, and pump house authorized under Automatic Board Order (ABO) issued as Permit No. 10012, 1974 - Lawrence C. Harris). [Additional Reference(s): DWR Levee Log, 2005]. FS Date: 10/10/2013

WS view: gate valve handle (center) on levee slope.

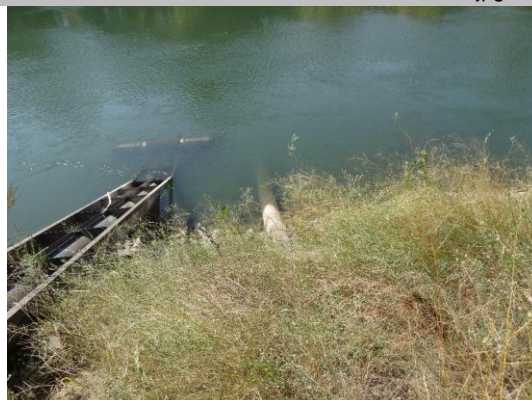
Photo 2 of 3 : UCIP\_FA\_2018\_22632\_38177.jpg

WS view: inlet steel pipe (right) immersed into channel water.

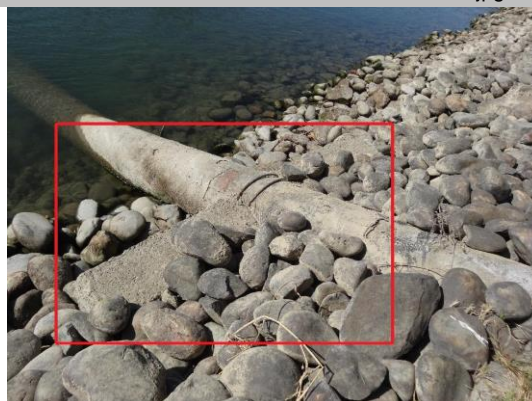
Photo 3 of 3 : UCIP\_FA\_2018\_22632\_38176.jpg

Comment Code						
Inspector Comment						
FS_ID:22632 DS_ID:22492 EP_NO: 10012 Repair Type: Non-Urgent Crossing Status: Found UCIP Comments: - abandoned pumphouse on landside toe. Needs confirmation from LMA or DWR Inspector about abandonment of pumphouse.- headwall on channel bank. FIELD_STRUCT_DESC: 24-inch steel irrigation discharge pipe through the levee, 24 feet below the crown. Slide gate on the waterside (WS) shoulder. Abandoned pump house on the landside (LS) slope. (Retention of a 24-inch steel pipe through the levee, 24 feet below the crown, slide gate, and pump house authorized under Automatic Board Order (ABO) issued as Permit No. 10012, 1974 - Lawrence C. Harris). [Additional Reference(s): DWR Levee Log, 2005]. FS Date: 10/10/2013

WS view: closer view of inlet steel pipe immersed into channel water.  
Pipe was supported by concrete headwall.

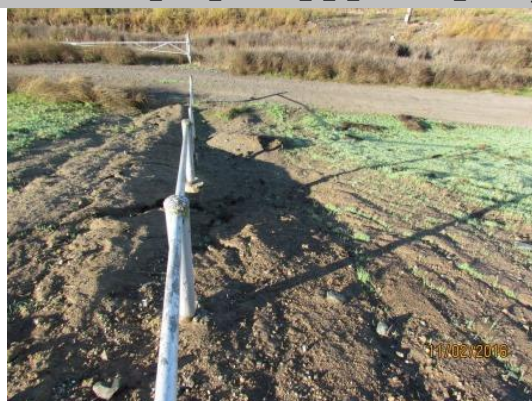
Photo 2 of 2 : FA\_2018\_RD1660\_9\_6\_20180905\_00002.jpg

Another view of the slope instability looking from the levee crown.

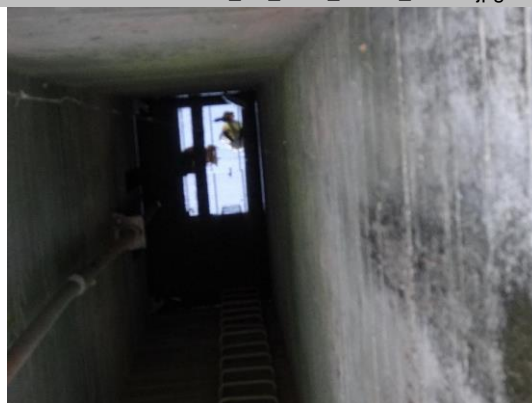
Photo 2 of 3 : UCIP\_FA\_2018\_22663\_38247.jpg

WS view: inside view of concrete box on levee slope. Slide gate in concrete box.

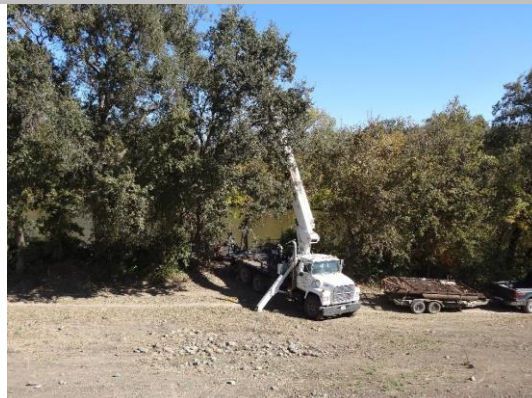
Photo 1 of 3 : UCIP\_FA\_2018\_22705\_38394.jpg

Comment Code						
Inspector Comment						
FS_ID:22705 DS_ID:22499 EP_NO: N/A Repair Type: Non-Urgent Crossing Status: Found UCIP Comments: Pressure relief valve on landside levee slope.Pump platform under construction for upgrade (raising platform)Look for new upgrade/revision permit. FIELD_STRUCT_DESC: 18-inch steel irrigation discharge pipe through the levee, 5.8 feet below the crown. Pump in the channel. Gate valve on the landside (LS) berm. Pipe discharges into a 4-foot by 4-foot concrete box on the LS berm. 2-inch electrical conduit of an unknown material through the levee, 3 feet below the crown. (Plans for construction of a pumping plant with an 18-inch discharge pipe through the levee authorized under Permit No. 4215, 1963 - S. A. McKeehan). [Additional Reference(s): DWR Levee Log, 2005]. FS Date: 10/15/2013

WS view: pump platform under construction.

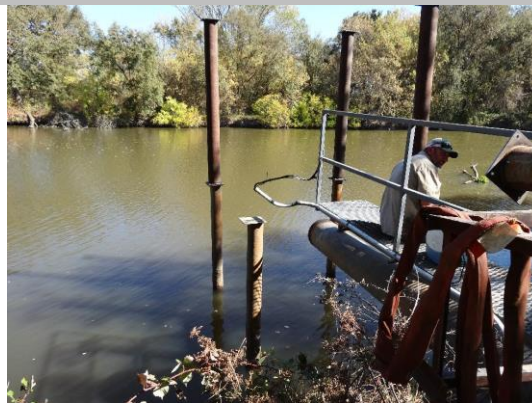
Photo 2 of 3 : UCIP\_FA\_2018\_22705\_38393.jpg

WS view: pump platform under construction. 18" steel pipe and 2" electric conduit under steel platform.

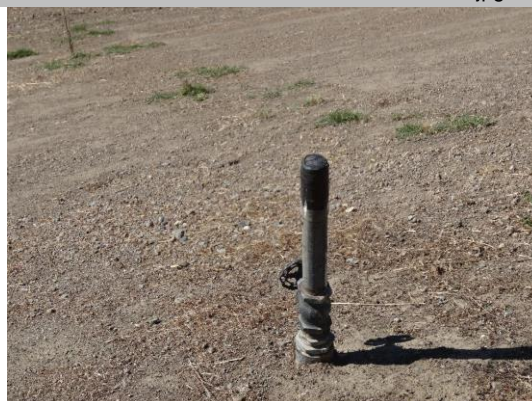
Photo 3 of 3 : UCIP\_FA\_2018\_22705\_38392.jpg

Comment Code						
Inspector Comment						
FS_ID:22705						
DS_ID:22499						
EP_NO: N/A						
Repair Type: Non-Urgent						
Crossing Status: Found						
UCIP Comments: Pressure relief valve on landside levee slope.Pump platform under construction for upgrade (raising platform)Look for new upgrade/revision permit.						
FIELD_STRUCT_DESC: 18-inch steel irrigation discharge pipe through the levee, 5.8 feet below the crown. Pump in the channel. Gate valve on the landside (LS) berm. Pipe discharges into a 4-foot by 4-foot concrete box on the LS berm. 2-inch electrical conduit of an unknown material through the levee, 3 feet below the crown. (Plans for construction of a pumping plant with an 18-inch discharge pipe through the levee authorized under Permit No. 4215, 1963 - S. A. McKeehan). [Additional Reference(s): DWR Levee Log, 2005].						
FS Date: 10/15/2013

LS view: pressure relief valve on levee slope.

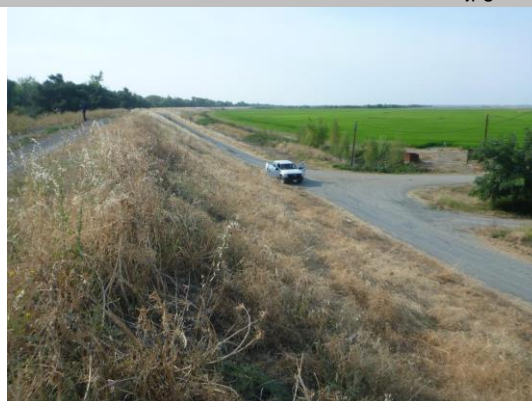
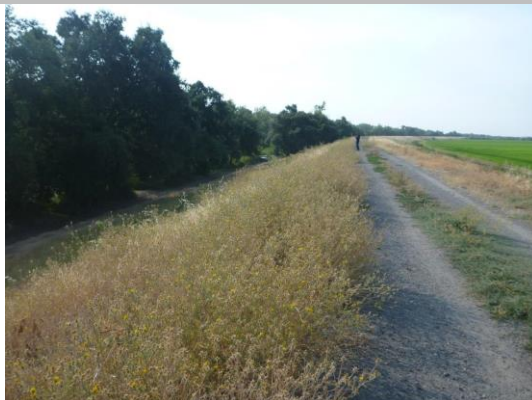
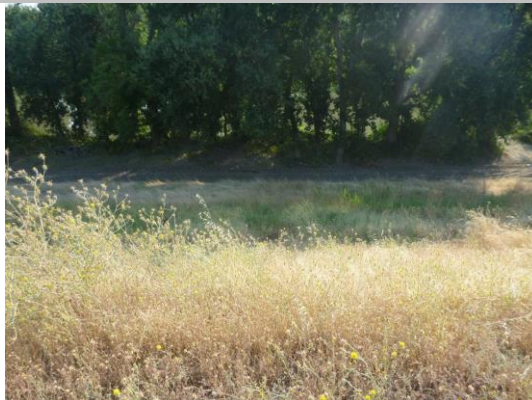
LM Start	5.12	Rating **	A/W	Issue No.	9	
LM End	5.12	Issue Type +	Ob	Location *		
Category	Supplemental			GPS Latitude/Longitude		
				Start	End	
Item	2017 Storm Damage			39.102537 °	39.102537 °	
				-121.775390 °	-121.775390 °	
DWR ID	DWR_RD1660_02_f_2017_9					
Comment Code						
Inspector Comment						
Levee Evaluation Comments						
Description:						
Site ID No:157						
Site Designation:RD 1660-01						
Repair Type: Seepage (B)						
Rating:Area of Concern						
Field Date:8/3/2017						
Notes: small bulges, levee prone to seepage

LM Start	5.12	Rating **	A/W	Issue No.	9 (cont)	
LM End	5.12	Issue Type +	Ob	Location *		
Category	Supplemental			GPS Latitude/Longitude		
				Start	End	
Item	2017 Storm Damage			39.102537 °	39.102537 °	
				-121.775390 °	-121.775390 °	
DWR ID	DWR_RD1660_02_f_2017_9					
Comment Code						
Inspector Comment						
Levee Evaluation Comments						
Description:						
Site ID No:157						
Site Designation:RD 1660-01						
Repair Type: Seepage (B)						
Rating:Area of Concern						
Field Date:8/3/2017						
Notes: small bulges, levee prone to seepage

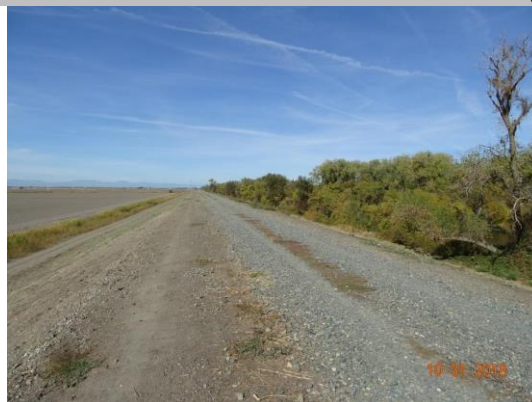
Photo 1 of 1 : FA\_2018\_RD1660\_9\_8\_20181102\_00017.jpg

LM Start	<b>5.66</b>	Rating **	A/W	Issue No.	<b>21</b>
LM End		Issue Type +	Ob	Location *	
Category	Supplemental			GPS Latitude/Longitude	
				Start	End
Item	2017 Storm Damage			39.108209 °	°
				-121.782280 °	°
DWR ID	DWR_RD1660_02_f_2017_21				
Comment Code					
Inspector Comment					
Levee Evaluation Comments					
Description:					
Site ID No:173					
Site Designation:248-17					
Repair Type: Seepage					
Rating:					
Field Date:					
Notes:

View of no vegetation on both slopes.

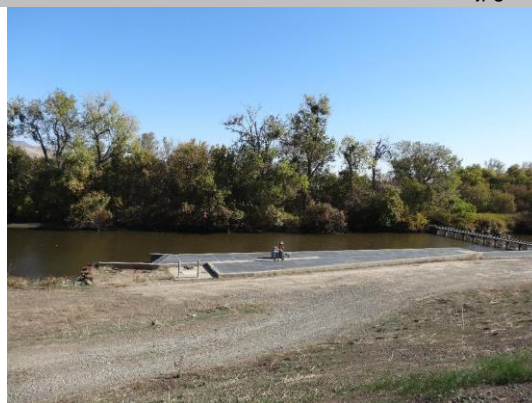
Photo 1 of 3 : UCIP\_FA\_2018\_22708\_38406.jpg

Comment Code						
Inspector Comment						
FS_ID:22708						
DS_ID:22505						
EP_NO: N/A						
Repair Type: No Action Needed						
Crossing Status: Found						
UCIP Comments: - inlet structure 160 ft off the levee center on landside drainage ditch.						
FIELD_STRUCT_DESC: 48-inch steel gravity drainage pipe through the levee, 29 feet below the crown. Slide gate and concrete bulkhead on the riverbank. Staff gage on the waterside (WS) berm. (Retention of a 48-inch corrugated metal pipe (CMP) through the levee, 29 feet below the crown, a slide gate, and a concrete bulkhead authorized under Automatic Board Order (ABO) No. 10021, 1974 - Butte Slough Irrigation Company, care of Tarke Warehouse). [Additional Reference(s): DWR Levee Log, 2005. USACE Sacramento O&M Manual 133, August 1955, (Station 433+43), 48-inch CMP referenced].						
FS Date: 10/15/2013

WS view: overview of concrete box on channel bank. It looks like a fish ladder. Pipe discharges into this box.

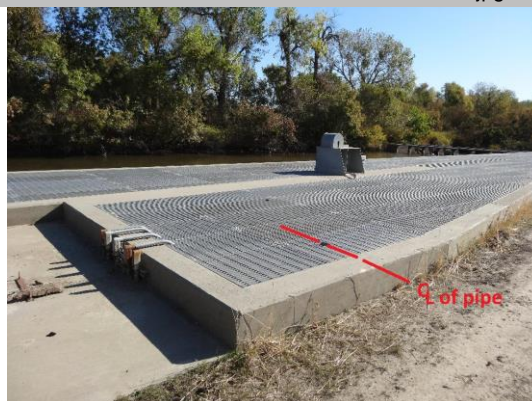
Photo 2 of 3 : UCIP\_FA\_2018\_22708\_38405.jpg

Comment Code						
Inspector Comment						
FS_ID:22708						
DS_ID:22505						
EP_NO: N/A						
Repair Type: No Action Needed						
Crossing Status: Found						
UCIP Comments: - inlet structure 160 ft off the levee center on landside drainage ditch.						
FIELD_STRUCT_DESC: 48-inch steel gravity drainage pipe through the levee, 29 feet below the crown. Slide gate and concrete bulkhead on the riverbank. Staff gage on the waterside (WS) berm. (Retention of a 48-inch corrugated metal pipe (CMP) through the levee, 29 feet below the crown, a slide gate, and a concrete bulkhead authorized under Automatic Board Order (ABO) No. 10021, 1974 - Butte Slough Irrigation Company, care of Tarke Warehouse). [Additional Reference(s): DWR Levee Log, 2005. USACE Sacramento O&M Manual 133, August 1955, (Station 433+43), 48-inch CMP referenced].						
FS Date: 10/15/2013

WS view: concrete box on channel bank. Pipe end with slide gate. Pipe discharges into this box.

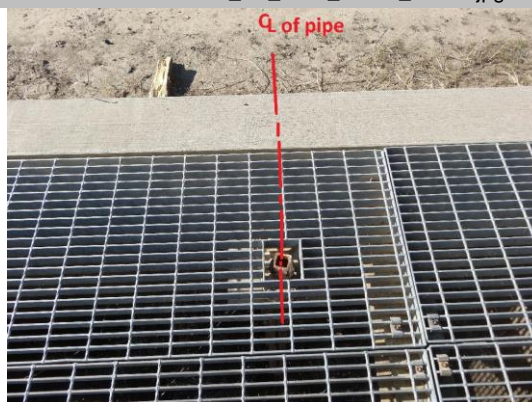
Photo 3 of 3 : UCIP\_FA\_2018\_22708\_38409.jpg

WS view: concrete box on channel bank. Pipe discharges into this box. A slide gate inside this box.
